# Manhole Inspection Summary

Manhole # S55A\_\_017MH

Insp Date: **6/24/08 11:07 AM**

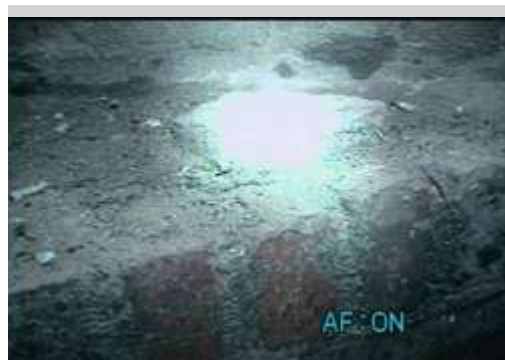
misc. bench debris

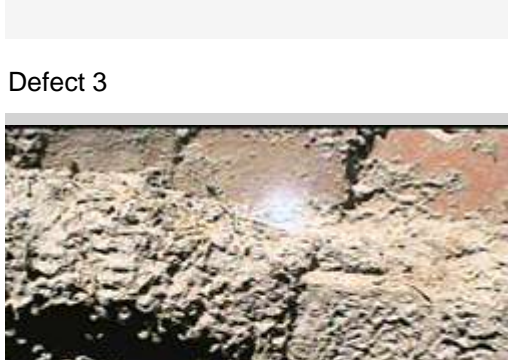
channel debris

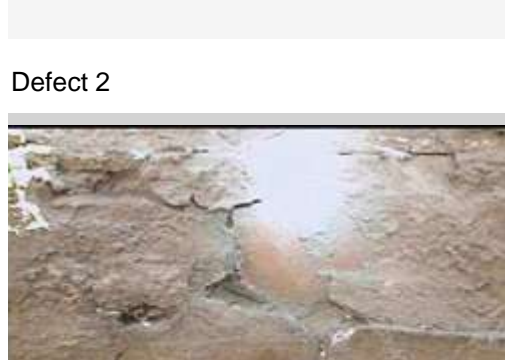
bench debris

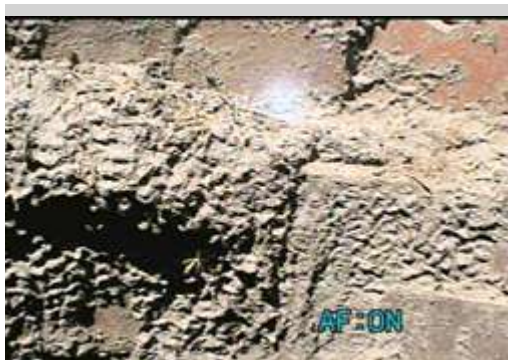
Defect 3

Infiltration: ☐ None ☒ **Joint** ☐ Cracks ☒ **Mortar** ☐ Roots ☐ Wall

corbel infiltration

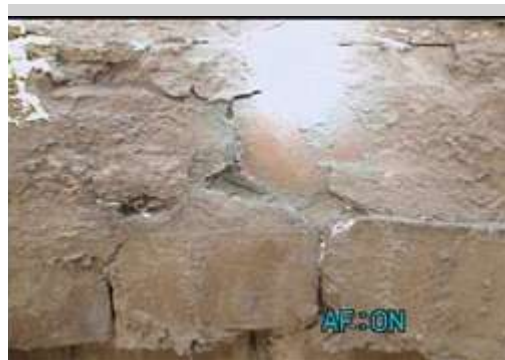
Defect 2

Condition: ☐ Sound ☐ Cracked ☐ Root Intrusion ☐ Loose Brick ☒ **Deteriorated**

corbel deteriorated

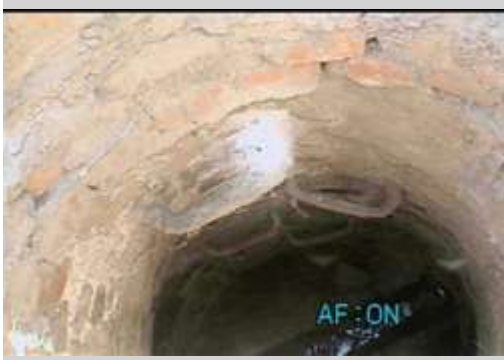
### Defect 1

Condition: ☐ Sound ☐ Cracked ☐ Root Intrusion ☒ **Loose Brick** ☐ Deteriorated

**Steps** Count: **4** Missing: **0** ☒ **Corroded**

chimney loose bricks corroded steps

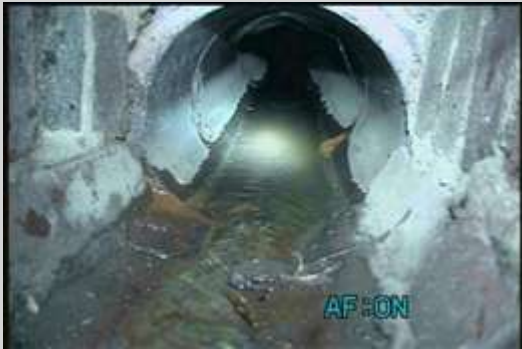
12 O'Clock Outflow

8 in. Circular Gravity Sewer  
Pipe Out @ 12 O'Clock

Pipe Material: **Clay** ☐ Pipe Lined

Invert Depth: **8.89** (ft.) Flow Characteristics: **Slow**

Infiltration: **None** Pipe Seal Cond: **Unknown**

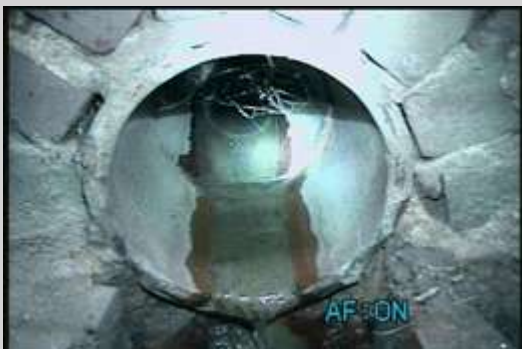
6 O'Clock Inflow

8 in. Circular Gravity Sewer  
Pipe In @ 6 O'Clock

Pipe Material: **Clay** ☐ Pipe Lined

Invert Depth: **8.64** (ft.) Flow Characteristics: **Slow**

Infiltration: **None** Pipe Seal Cond: **Unknown**
